PADANARAM RESERVOIR DAM CT 00067

PHASE I INSPECTION REPORT NATIONAL DAM INSPECTION PROGRAM

JULY 1980

Identification Number:	CT 00067
Name:	Padanaram Reservoir Dam
Town:	Danbury
County and State:	Fairfield County, Connecticut
Stream:	Padanaram Brook
Date of Inspection:	April 21, 1980

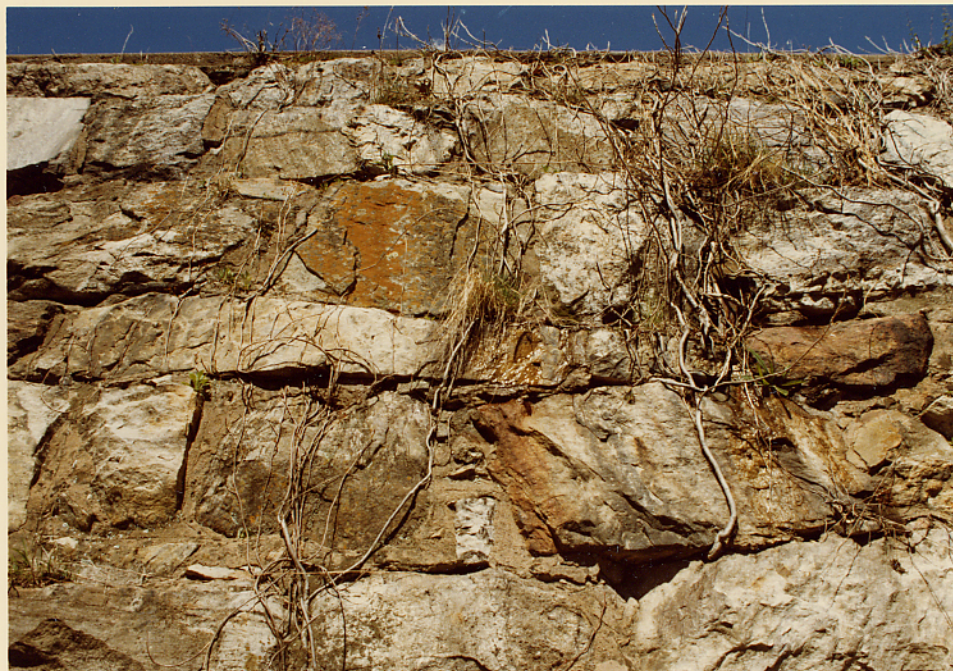
PHOTO 1
DOWNSTREAM FACE OF DAM

The general structural stability of the dam is good as evidenced by the vertical, horizontal and lateral alignment of the face and top of the dam and by the age of the dam. A bulge was noted on the front face of the dam east of the centerline, extending about 1/4 of the length. This bulge, however, appears to have originated during construction because no cracking of the masonry or mortar was observed. Some joints in the masonry need repointing as evidenced by the vegetative growth from the joints.

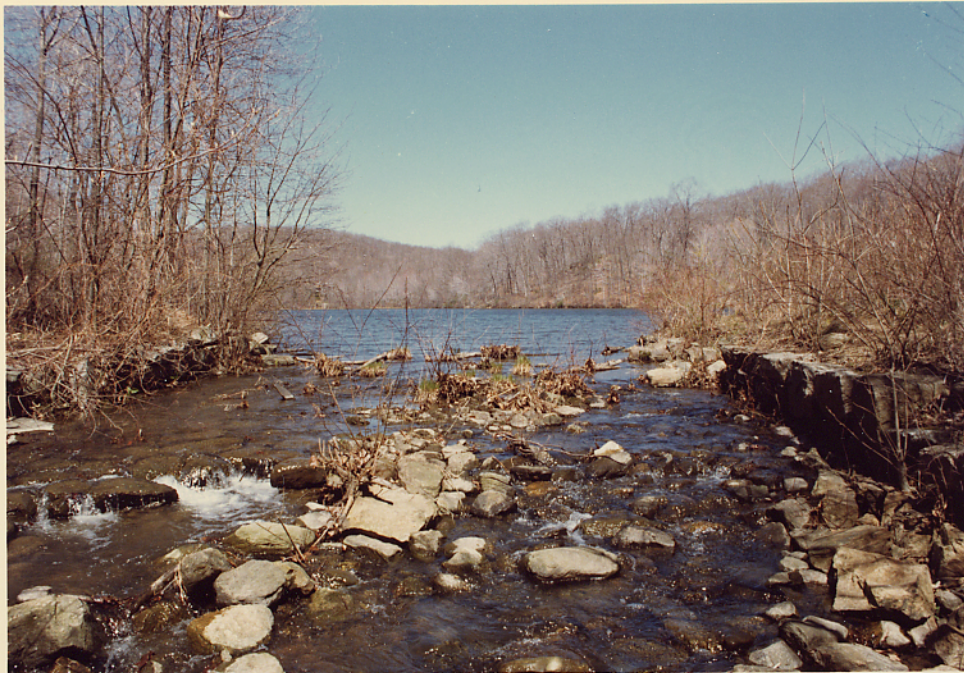
PHOTO 3
SPILLWAY-UPSTREAM

The spillway is a stone weir that is in fair condition (Photo 3). The approach channel is not well defined and is the natural slope of the bottom of the pond. The training walls of the spillway are also stone masonry and are in fair condition. The downstream channel is a natural channel with riprap in some areas. It is 24 feet wide with steep side slopes (Photo 4). The condition is good except for areas of the channel where debris is cluttered.

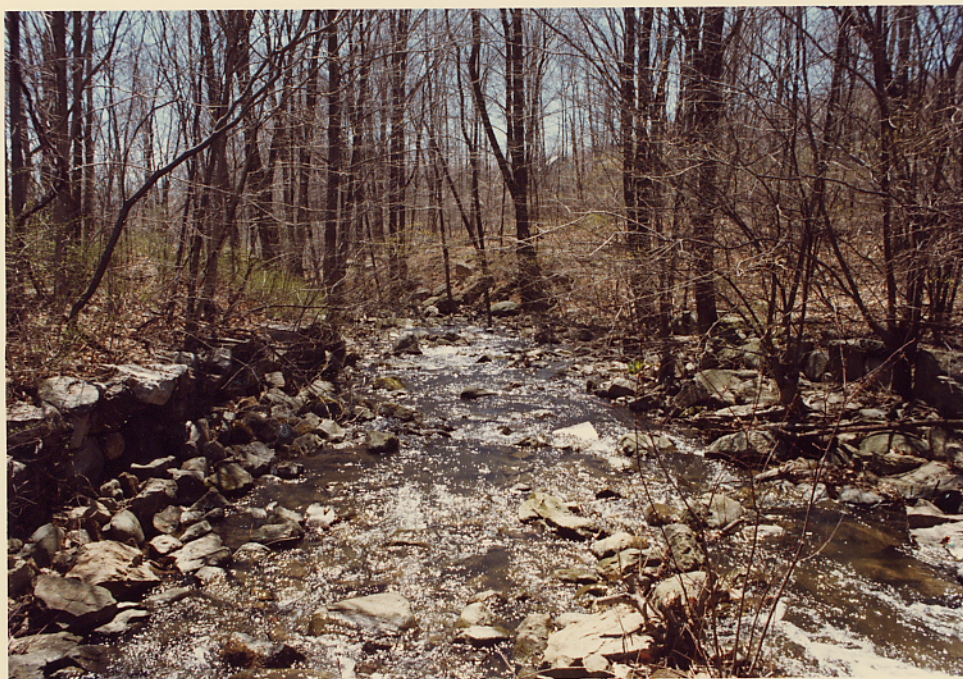
PHOTO 4
SPILLWAY CHANNEL-DOWNSTREAM

The spillway channel is in fair condition. It should be cleared of the accumulated debris and some of the stones realigned.

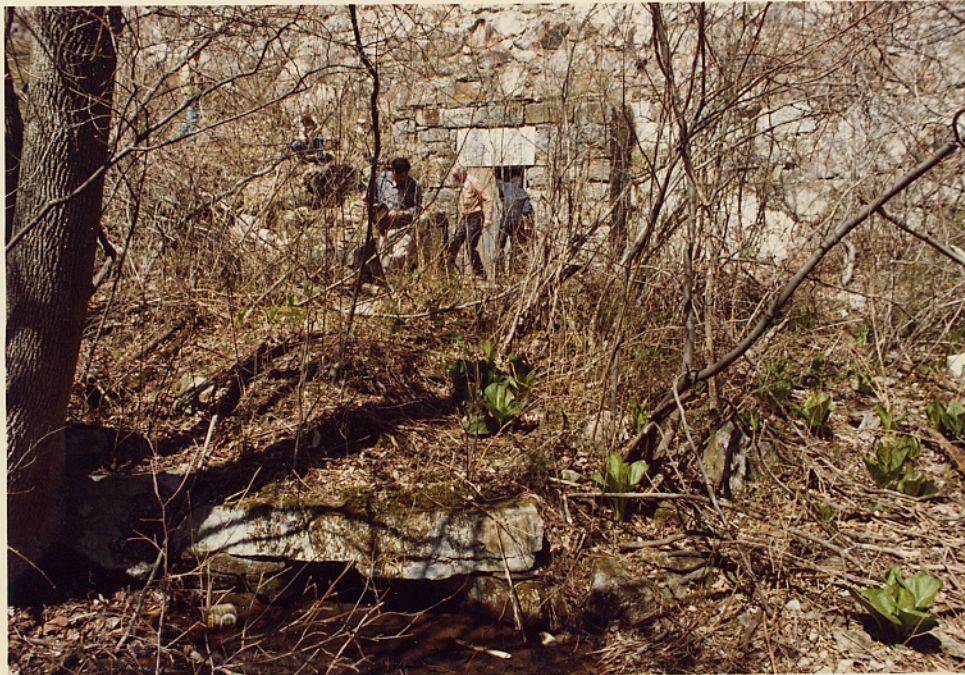
PHOTO 6
LOWER GATE HOUSE & OUTLET

c. Appurtenant Structures - The lower gate house (Photo 6) is structurally sound, however, the valve is not operating and the type and size of the discharge pipe is unknown. The discharge pipe outlets approximately 50 feet downstream and is silted-up and has not experienced flow in years.

(3) Discharge valve and pipe should be repaired. Valve for the discharge pipe should be on the upstream side of the embankment.

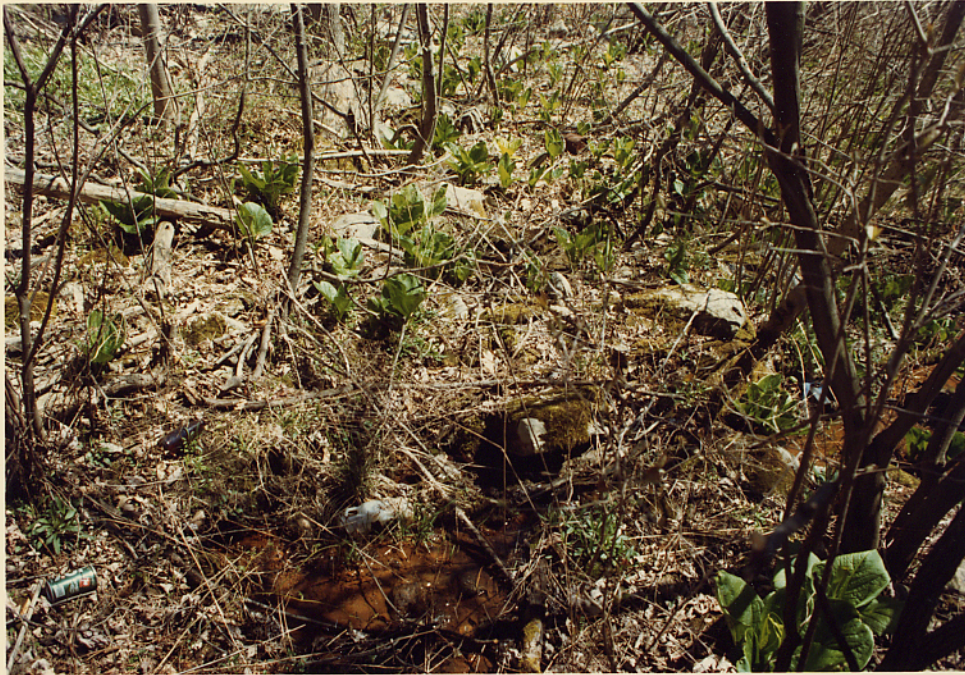
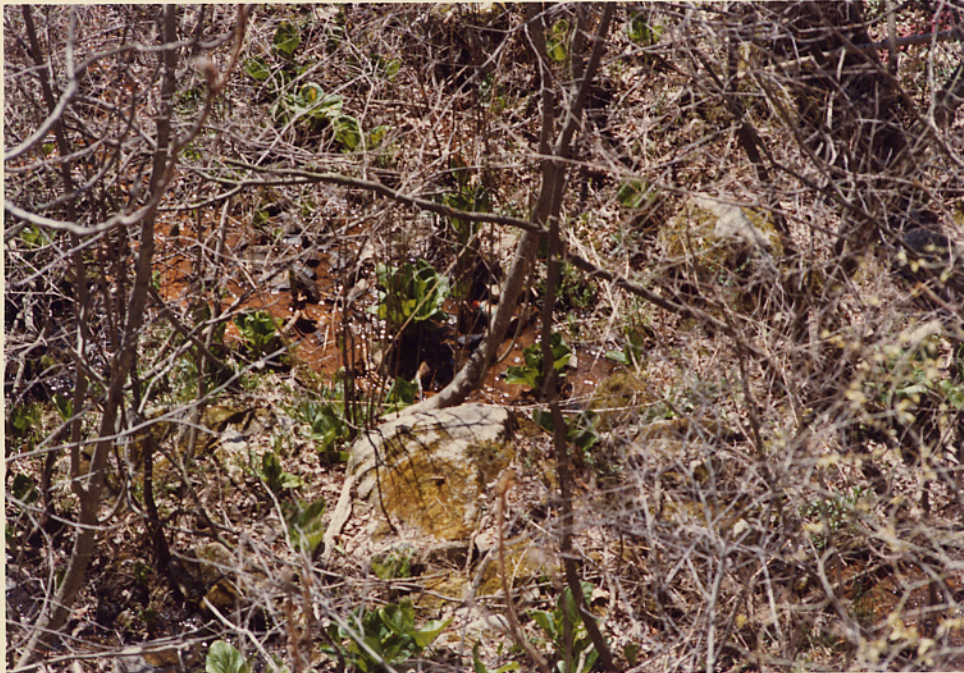
Just below the toe of the dam and to the east of the gate house, there is a steady seepage flow (Photos 7 and 8) which was estimated to be approximately 50 to 75 gallons per minute. This seepage is clear and does not show any signs of particle movement. The estimated quantity of flow is from the entire area as shown on the Photo Location Plan.

PHOTO 7
SEEPAGE NEAR TOE OF DAM

PHOTO 8
SEEPAGE NEAR TOE OF DAM

It is recommended that the owner engage the services of a qualified registered engineer experienced in the design of dams to investigate the seepage through the dam and prepare a detailed hydraulic/hydrologic study to determine the spillway's adequacy.
